# FABRICATION OF AEROSPACE COMPONENTS AND THEIR CHARACTERIZATION USING NON-DESTRUCTIVE EVALUATION METHODS

L MAHESH

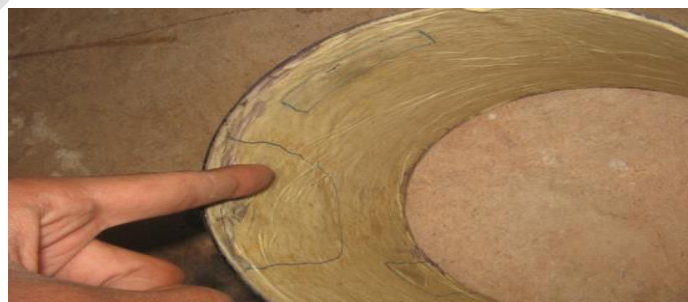
EPDM rubber bonded inside to Maraging steel casing

The abrasion process is used for obtaining the rough surface finish on the inner surface of the Maraging steel, epoxy resin is applied to the inner surface. EPDM rubber liner is bonded inside to the metal casing by epoxy resin and allowed to bond firmly. The de-bonding areas are artificially created for the study with the external source.

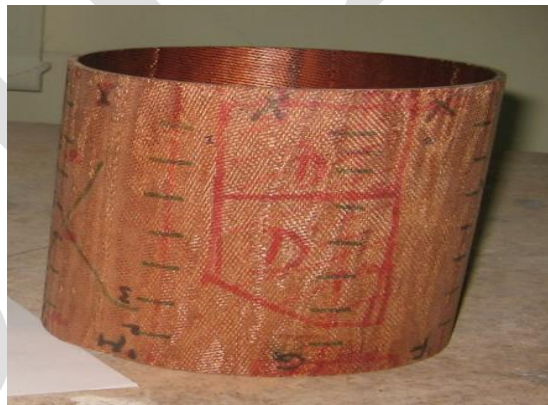
**High Silica Phenolic liner**

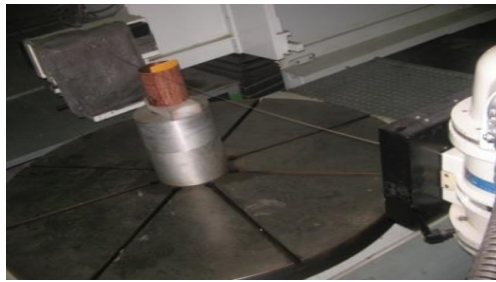
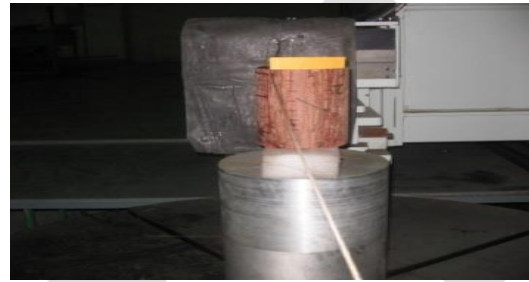
**Normal Radiography experimental setup**

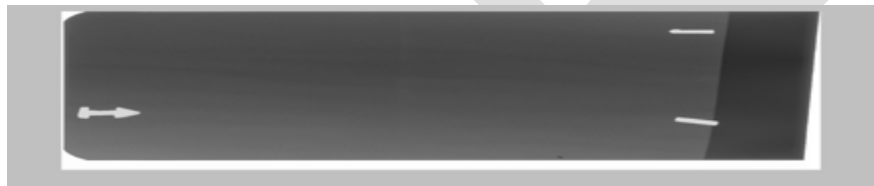
**Normal Radiograph of High Silica Phenolic liner**

From the Radiograph, no defects are observed in normal method. As the defects are not in parallel to the direction of X-ray beam travel and therefore not detected by this method. Hence Tangential Radiography is conducted.

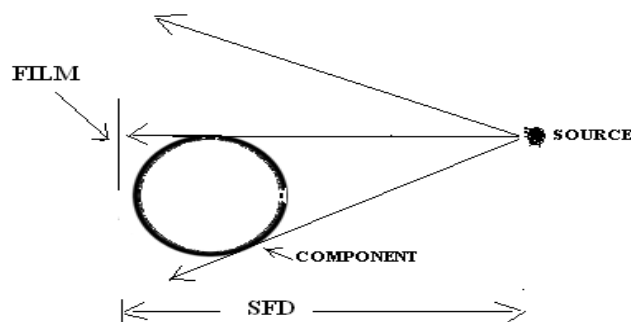
**Tangential Radiography schematic Block diagram**

The experiment was conducted on Pantak 450kV X-ray machine. In this method the liner is zone marked with lines and positioned perpendicular to the X-ray beam. The machine parameters are set to be X-ray Energy: 85kV, Tube current: 2.7mA and exposure time: 2 mins. A T200 (Kodak) X-ray film is placed perpendicular to the tangent drawn from source to the film center to record the differential absorption of the radiation. The experiment is conducted individually at each and every tangent at all around the component. The film is processed using an automatic film processing machine and viewed under film viewer. Finally, films are digitized employing an AGFA Film Digitizer for preserving the data and the following results are observed.

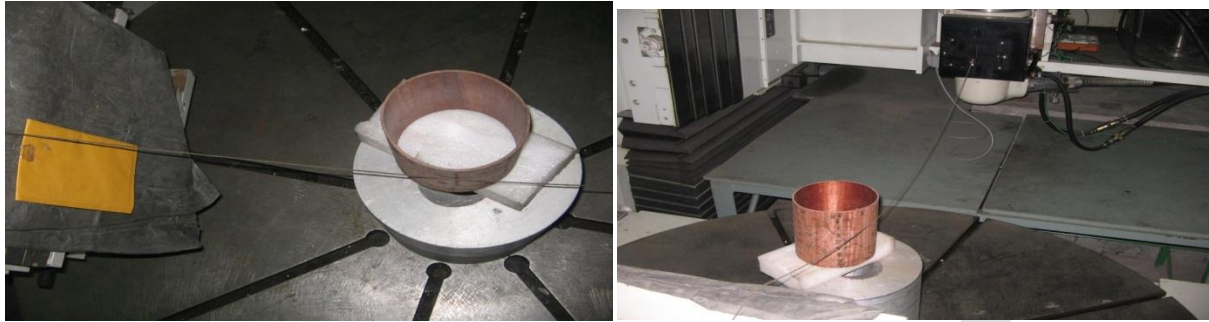
**Tangential Radiography experimental set up**

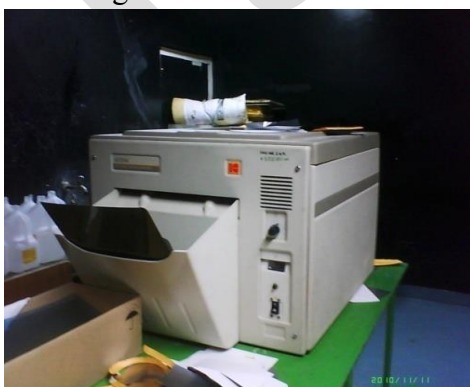
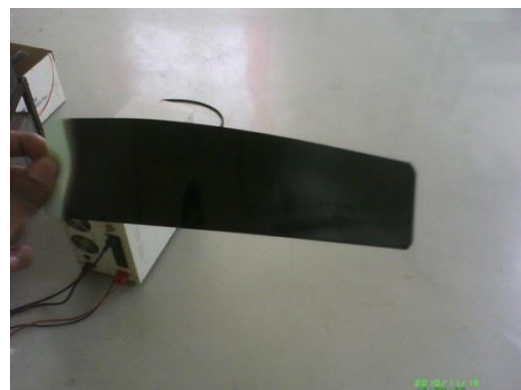
**Automatic film processing machine (Kodak)**

In the processing procedure, the invisible image produced in the film by exposure to X-rays, Gamma rays or light is made visible and permanent. Processing is carried out under subdued light of a color to which the film is relatively insensitive. The film is first immersed in a developer solution, which causes the areas exposed to radiation to become dark, the amount of darkening for a given degree of development depending on the degree of exposure. After development, and sometimes after a treatment designed to halt the developer reaction abruptly, the film passes into a fixing bath. The function of the fixer is to dissolve the darkened portions of the sensitive salt. The film is then washed to remove the fixing chemicals and solubilized salts, and finally is dried. Processing techniques can be divided into two general classes: "Manual Processing" and "Automated Film Processing".

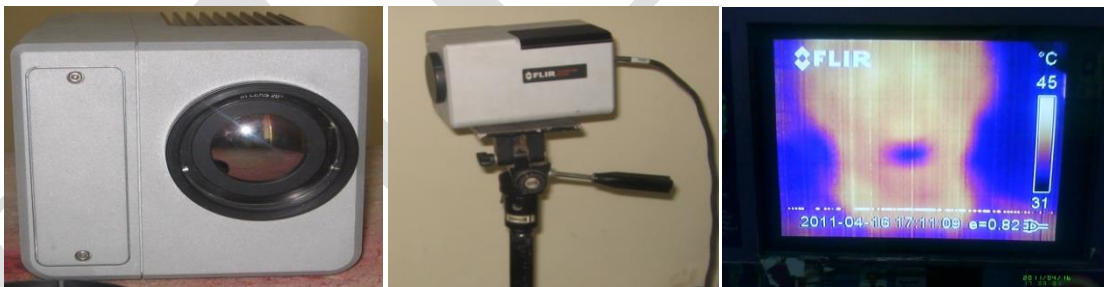
**ThermaCAM SC3000**

The Thermal imaging for all the samples was carried out by using ThermaCAM SC3000 manufactured by FLIR systems. The system consists of a rugged IR camera with a built-in 20° lens, Quantum Well Infrared Photon Detector (QWIP) with sterling cooling (up to  $-203.15^{\circ}\text{C}$ , cooling down time  $<6\text{min}$ ) cycle, cables and connectors. The spectral response of the IR camera is  $8\text{-}9\mu\text{m}$ . The thermal resolution of the camera is  $0.03^{\circ}$  at  $30^{\circ}\text{C}$ . The lens that was used in this experiment has at 2M object distance 0.3, 6M field of view (FOV); Accuracy is  $\pm 2\%$  or  $\pm 2^{\circ}\text{C}$ . The image storage is 14 bit digital image and covers range of temperatures varying from  $-20^{\circ}\text{C}$  to  $2000^{\circ}\text{C}$ . The Thermograms are analyzed using ThermaCAM Researcher Professional software.

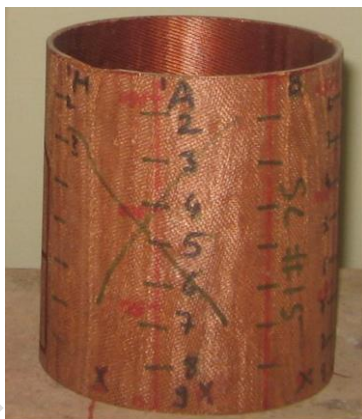
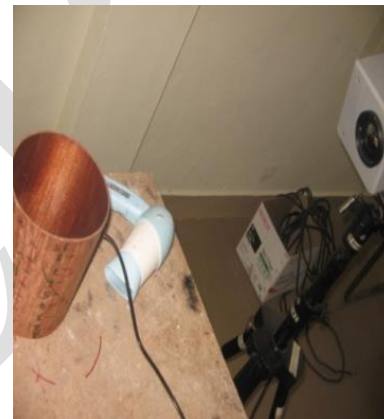
**High Silica Phenolic Through Transmission experimental set up**

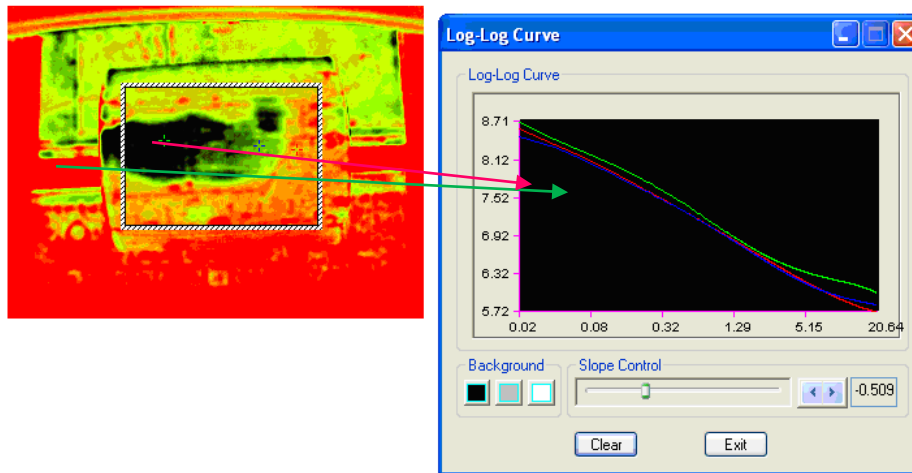
**Log-Log curve for High Silica Phenolic liner**

- Red line indicates non-defect
- Green line indicates defect-de-lamination shallow depth
- Blue line indicates defect-de-lamination deeper depth

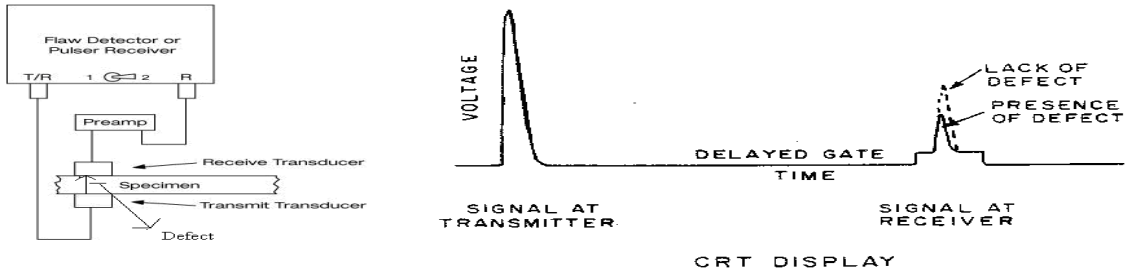
**The Through Transmission test configuration and a schematic of CRT Display**

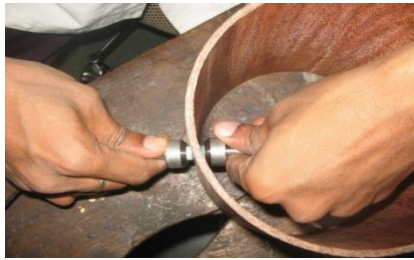
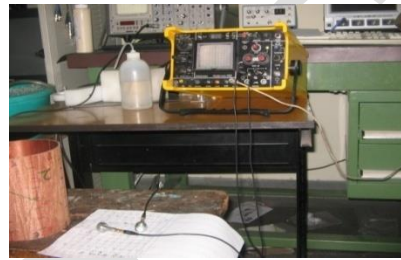
**Through Transmission test experimental set up**

Ultrasonic testing was successfully used in the present study to determine the defects in composite liner. The experimental set-up consisted of standard ultrasonic flaw detector and twin ultrasonic probes of diameter 10mm, the working frequency of which was 500 KHz. Before conducting the experiment, both (Transmitter and Receiver) probes need to calibrate as because of rubber pads, some of the energy might be losing. Both are held together and applied with some pressure to attain 90% of the fullscreen by increasing gain. Whenever positioning probes on the sample, need to adjust the gain until to attain the signal for 90% of the fullscreen. Hence it is calibrated for 47dB gain, attaining for 90% of the fullscreen. The magnitude of the received signal in terms of signal height on the screen of the ultrasonic flaw detector was recorded at various grid points on the component.

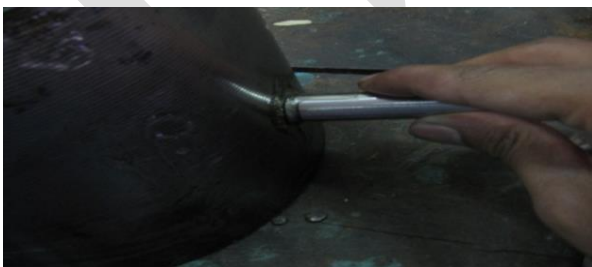
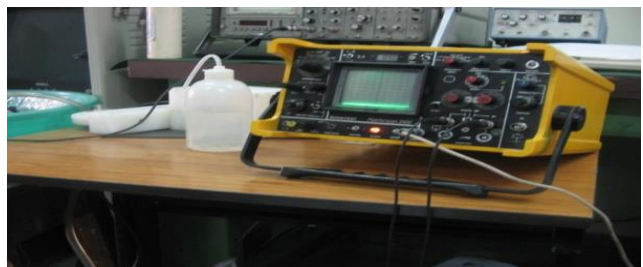
**Pulse-Echo test experimental set up**

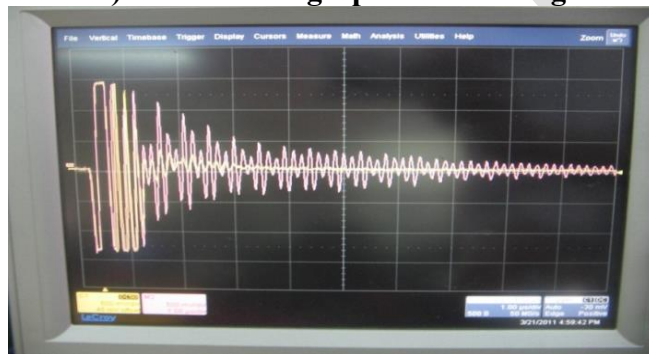
**b) Oscilloscope image**

From the Fig: b can clearly observe that the yellow signal (output signal) is following with the pink signal (reference signal), i.e., overlapping of signal (amplitude) taking place, then it is a de-bond point. Good bond point gives less miss match and minimum amplitude of reflections.

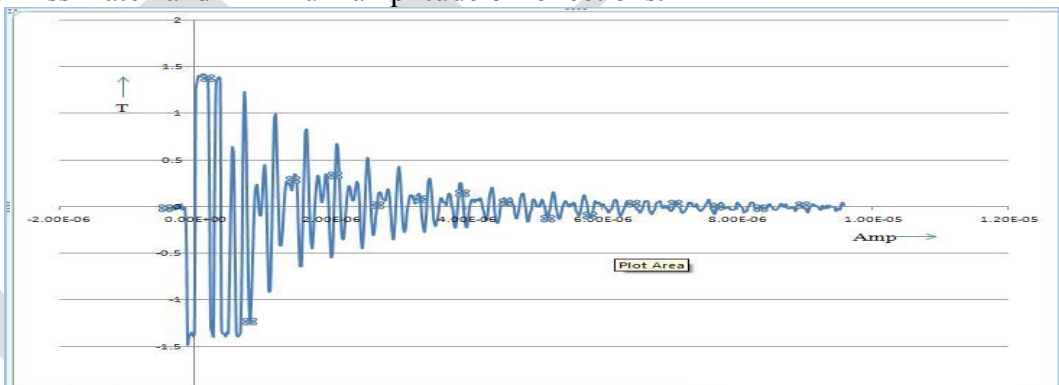
**c) Good bond side graph of the casing**
