GEOTECHNICAL INVESTIGATIONS FOR THE FAILURE REACHES OF THE MAIN CANAL OF SUBARNAREKHA IRRIGATION PROJECT

Problematic reach of Subarnarekha main canal

Geotechnical Investigations

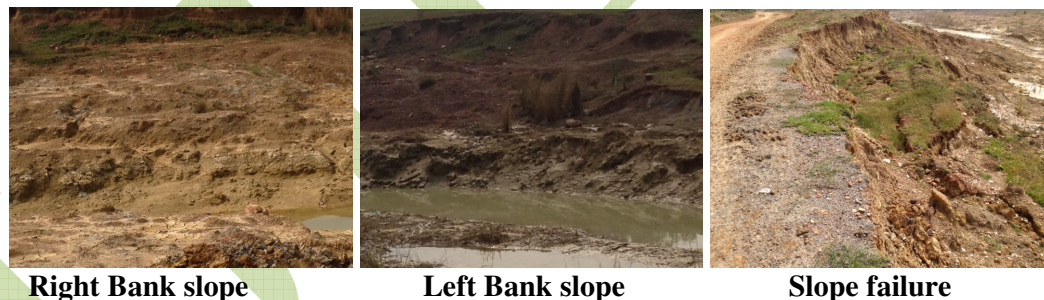
Figure 2 Severely Damaged Slopes

A particular reach of Subarnarekha main canal from RD 7950 to RD 8720 m which is of 770 m long is reportedly giving problems since 1990 when the excavation works for this reach was initially taken up. The problem has held back the scheme completion and consequently realization of envisaged benefits. The reach has repeatedly encountered canal side slope failures, though different side slopes (1.5H:1V, 2.5H:1V, 3.0H:1V, etc.) have been attempted.

CSMRS team visited the problematic area and noticed that the damage is more severe on right side slope than the left side slope. The project site was assessed and the soil samples were collected for characterizing at the laboratory. Figure 2 shows the severely damaged right and left bank slopes. Figure 3 shows the field investigations in progress.

The geotechnical investigations carried out on the problematic reaches of the Subarnarekha irrigation project ruled out the dispersivity characteristics of the soils at the side slope of the failure reach. However, it revealed that the presence of expansive soils in the problematic reaches which is the reason for the failure of slopes. The geotechnical properties of the soils were evaluated for design. Since the expansive soil at the failure reaches exhibit medium degree of expansion from the swelling pressure and fair shear strength characteristics, it was suggested that stabilization of the expansive soil may carried out along with the flatter slope or the problematic soils can be removed and replaced by non swelling soils. Proper geotechnical investigations are required in case of problematic soils so as to characterize these soils. Once the properties are evaluated accurately, it is possible to use these soils as construction and foundation materials with appropriate construction quality control/preventive measures.
