THE NEED TO CREATE A DEVICE THAT ALLOWS THE POSSIBILITY OF REMOTE DETERMINATION OF THE SPREAD OF TERMITES

This article presents the causes of damage to buildings by termites in the conditions of Uzbekistan and the method of their remote prediction. The hidden lifestyle of termites has been shown to cause more damage to interior parts of buildings.

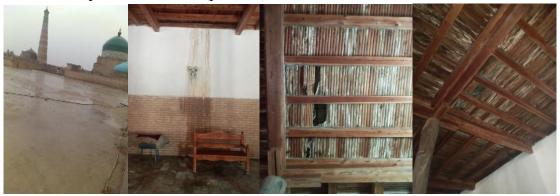
Figure - 2. Rain seeping into the building and damp rotting ceiling

According to our statistics, the roof of the mosque and its wooden pillars have been replaced and repaired several times. Improper repair of the roof part of the building led to accumulation of rainwater (no water escape slope), passing through the wall to the interior of the building, excessive humidity, and rotting of wood due to moisture in some places of the roof (photo 2).

Recommendations were made to the UNESCO representative office in Uzbekistan and the cultural heritage agency in order to eliminate the above defects, to immediately carry out reconstruction works on the roof of the mosque, to prevent moisture in the roof and to carry out light construction works while preserving the historical condition of the "Ichan Qala" Juma Mosque Museum.

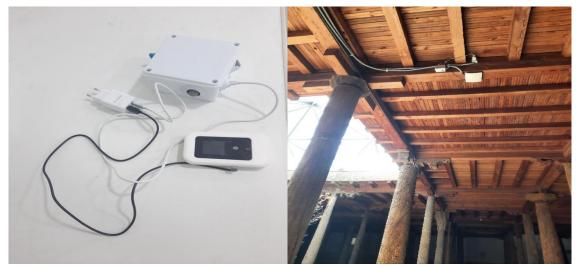
Figure 3. Device installed in Juma Masjid (Juma Masjid)

In order to create samples of modern and effective means of combating termites in the Juma Mosque and test them on site, a device was created and installed in the building of the Juma Mosque, which allows remote detection of termite distribution based on changes in relative humidity, temperature and gas content of the air in the building. Through this device, it was possible to identify the risk of termites in advance and implement measures to combat them (Figure 3).
